**Petition for the Reconsideration and  
Modification of the National  
Transportation Safety Board's Findings  
and Determination of the Probable Cause  
for the Crash of TWA Flight 800**

*The TWA 800 Project*  
*6/19/2013*

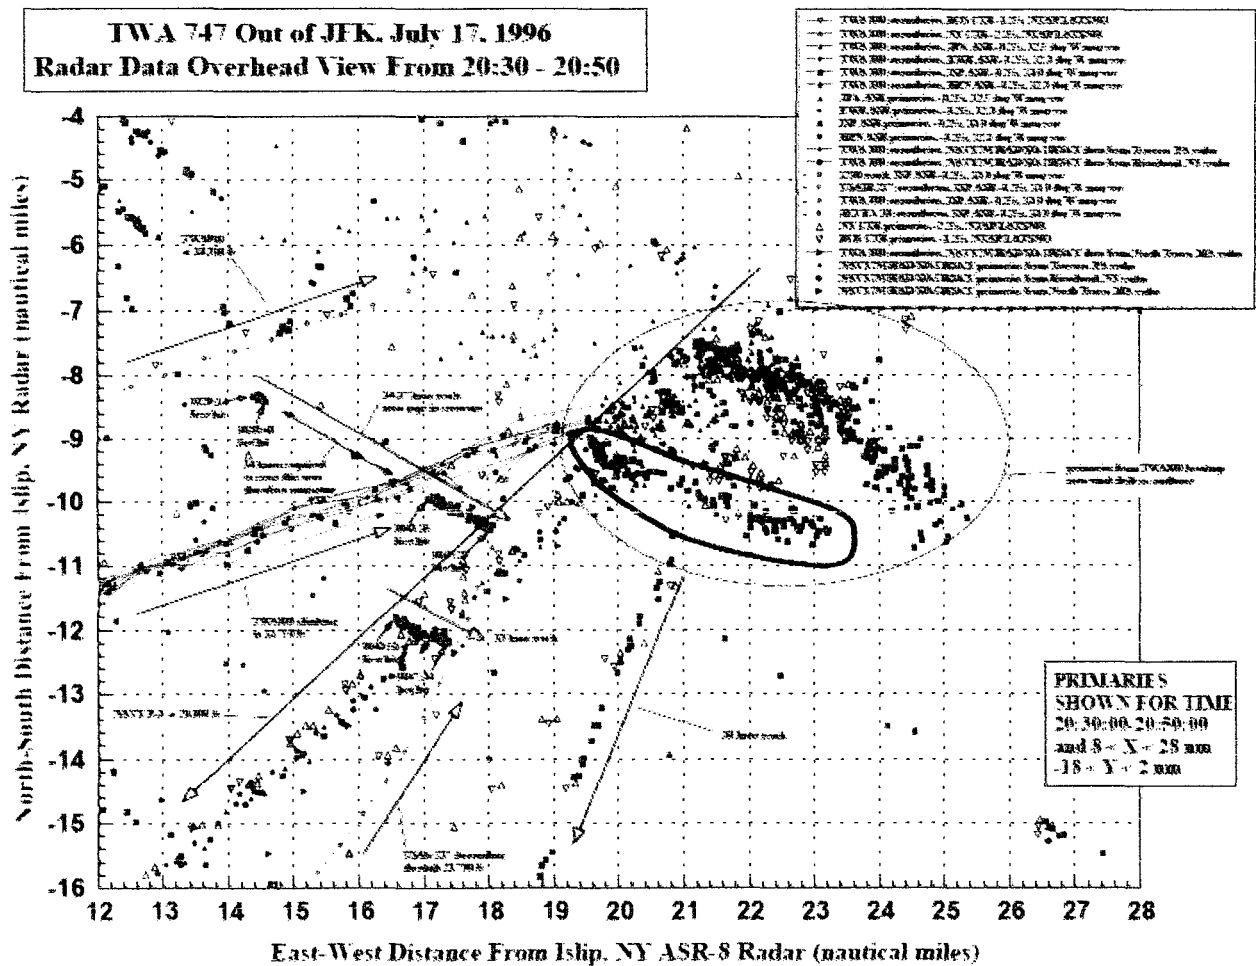
**Figure 1: NTSB radar plot from page 44 of the Airplane Performance Study (Exhibit 13A). The band of debris in question has been circled by the petitioners with a thick black line.**

At the 1997 NTSB hearing in Baltimore, NTSB investigator John Clark testified that the above-mentioned plume of radar returns (circled with a thick black line above) was “consistent with the explosion” that caused the crash. However, Mr. Clark did not provide a scientific basis for that conclusion nor did he attempt to further characterize that explosion by presenting an analysis of the subject radar returns. Our analysis of the speed and direction of the circled radar returns presented below demonstrates that the explosion responsible for the propagation of these returns was, in fact, a high velocity explosion--a detonation. The official NTSB theory for the crash is based on the assumption that the explosion in question was a low-velocity explosion or deflagration of fuel-air vapors and therefore cannot account for this radar-recorded detonation.

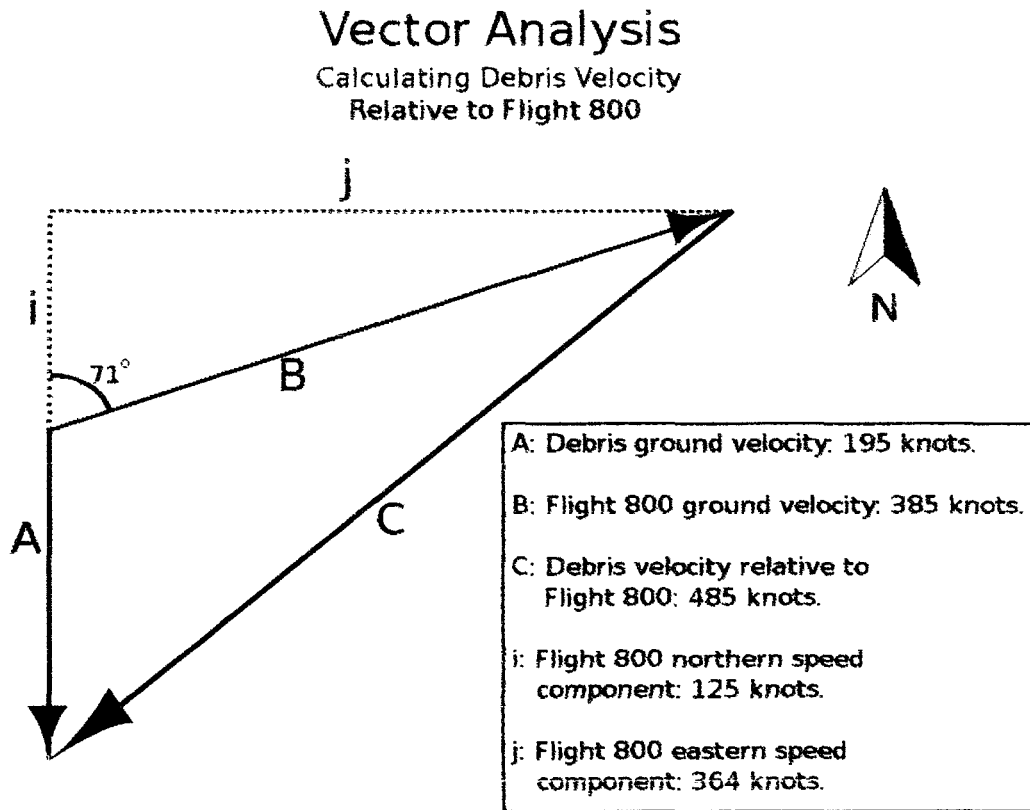
Using the Pythagorean Theorem, the average speed of the debris relative to the accident aircraft was between 463 and 495 knots or between 238 and 255 m/s.

**Figure 2:** Addition of Flight 800 and debris velocity vectors. The blue line labeled C represents the debris' velocity relative to Flight 800. Lines A and B represent the ground velocities of the debris and Flight 800 respectively. Lines i and j represent Flight 800's northern and eastern speed components.

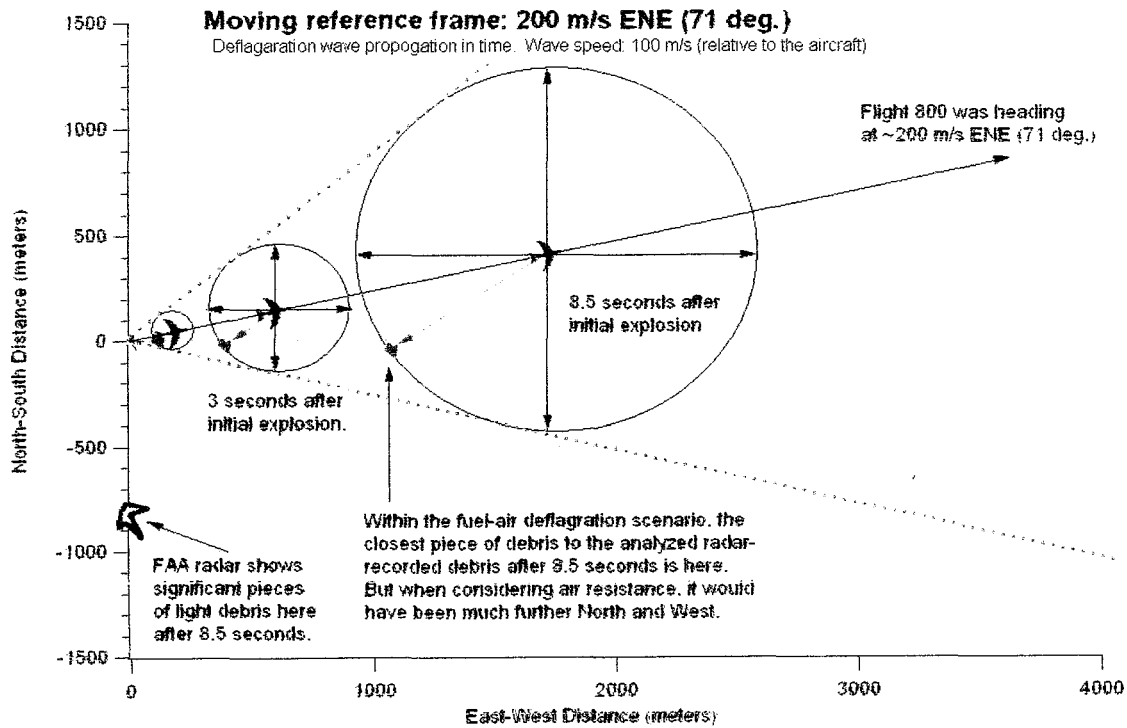
**Figure 3:** Maximum deflagration wave expansion at three points in time in TWA Flight 800's reference frame. Air resistance is neglected outside the aircraft to provide a best-case scenario for the NTSB's crash sequence. The red arrows point to hypothetical debris ejected by the deflagration. The 747 icons are not to scale.

In Figure 3, the circles represent the maximum expansion of the officially proposed fuel-air deflagration. The red dotted lines represent the maximum horizontal distance any piece of debris could have traveled in the first moments after the explosion. The hypothetical wreckage item colored red at the lower left edge of each circle represents the most dense and streamlined wreckage fragment, since the effects of air resistance would be lowest for such fragments. But as can be seen, even a fragment with those properties would still be more than one kilometer away from where radar sites recorded the debris plume at 8.5 seconds.

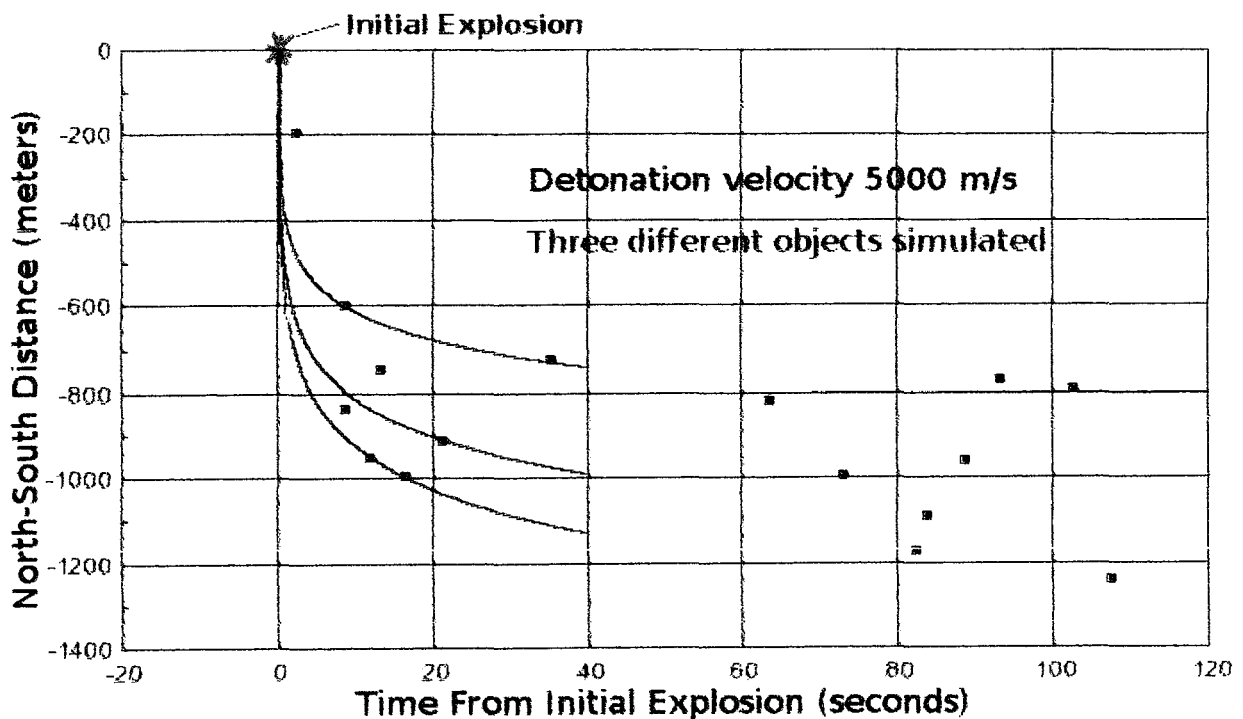
**Figure 4:** Three ballistics curves fit to north-south position vs. time from the Islip and White Plains radar sites. This plot only shows the north-south distances and speeds. Flight 800 was heading ENE at 385 knots. The small blue squares are a composite of Islip and White Plains FAA radar returns.
