Loss of Thrust in Both Engines After Encountering a Flock of Birds and Subsequent Ditching on the Hudson River

US Airways Flight 1549
Airbus A320-214, N106US
Weehawken, New Jersey
January 15, 2009

NTSB/AAR-10/03
PB2010-910403

Aircraft Accident Report

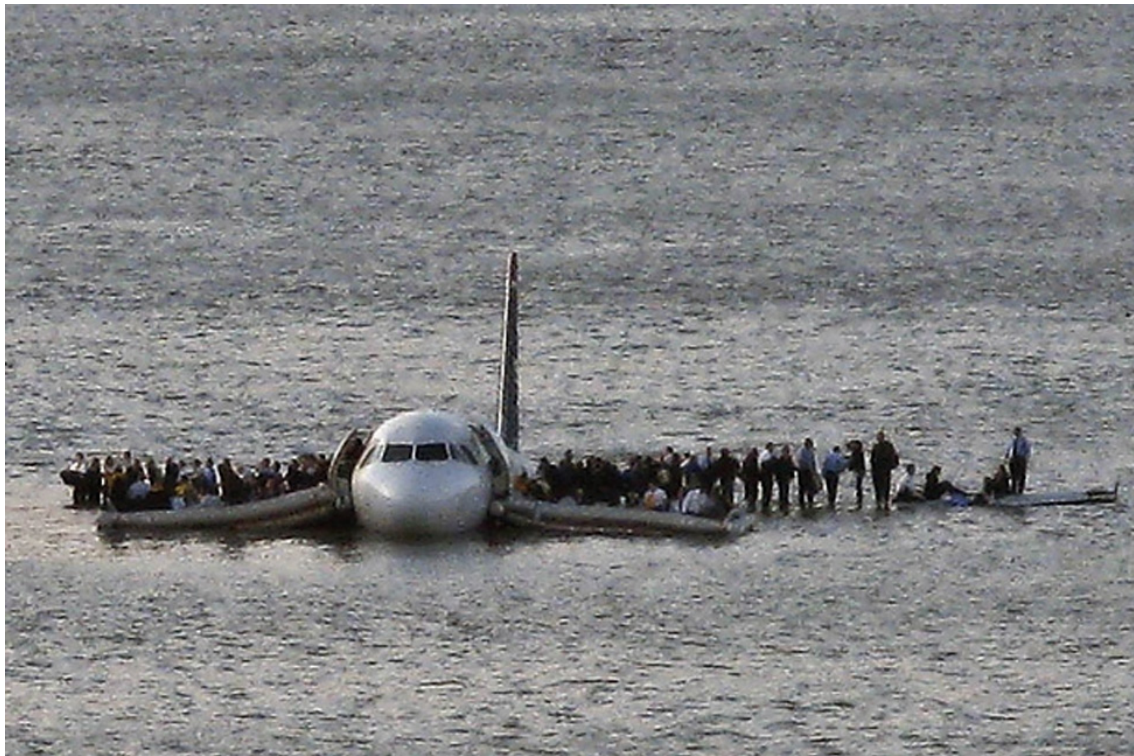
Within seconds after the ditching on the Hudson River, the crewmembers and passengers initiated evacuation of the airplane. Subsequently, all of the occupants were evacuated from the airplane and rescued by area responders. (See sections 1.15.5 and 1.15.6 for information about the emergency evacuation and response, respectively.) Figure 2 shows the airplane occupants on the wings and in the slide/rafts after the evacuation.

Figure 2. A photograph showing the airplane occupants on the wings and in the slide/rafts after the evacuation.

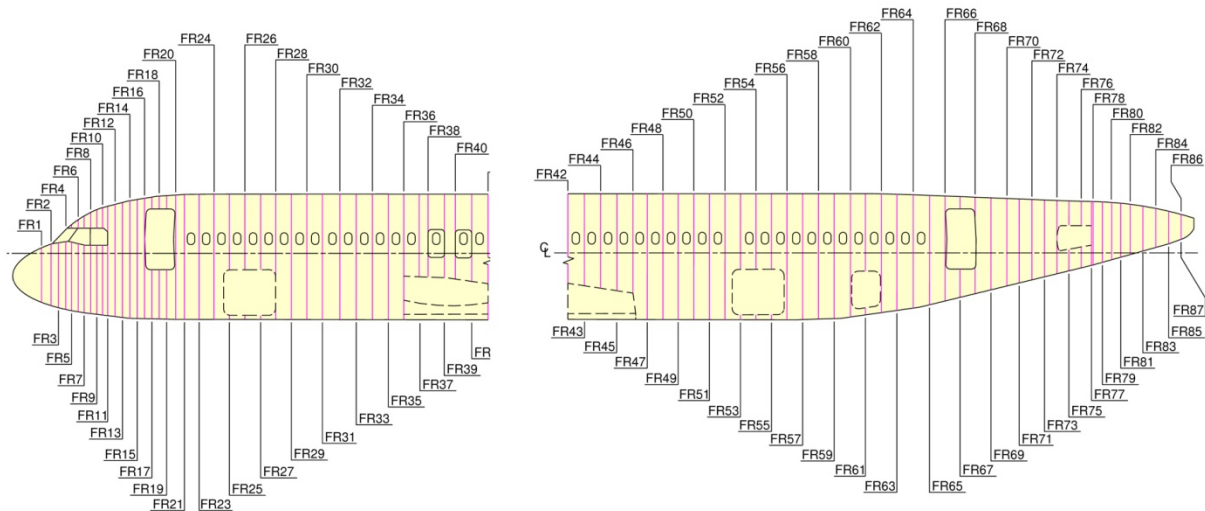
Figure 6. Diagram showing the A320 fuselage frame locations.

Specifically, portions of the left-side belly fairing aft of the wing were either fractured or missing. The right-side belly fairing was missing from FR37 to FR51. The lower left side of the rear fuselage was fractured between FR56 and FR64 and bent outward away from the airplane centerline. The lower right side of the rear fuselage was crushed and buckled inward from FR56 to FR70. The internal cargo structure was damaged, and the floor panels at FR57 were buckled upward.

The crossbeams from FR66 aft were sheared in the aft direction, but the longitudinal seat tracks remained in position. The lower third of the aft pressure bulkhead was sheared away, and the lower part of the fuselage was torn in the aft direction. The tail cone, including the APU, was separated from its attachment points to the fuselage, except for the right-side lower location, and no longer retained its conical shape.

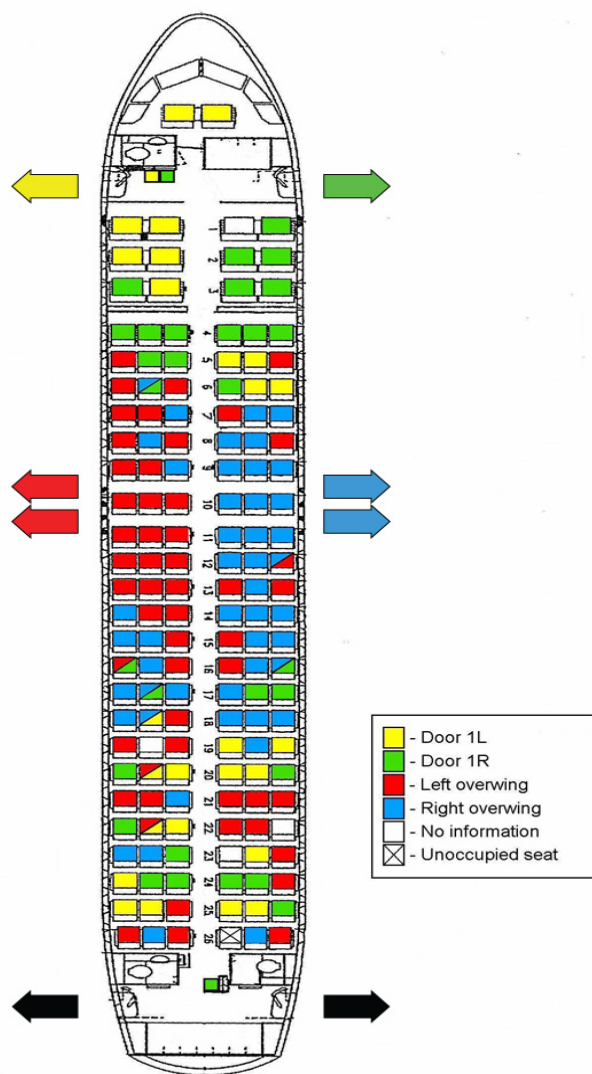
Figure 9. Occupant evacuation exit usage.

Note: Because of postevacuation passenger movement, the chart does not accurately indicate the locations where people were rescued. Additionally, several passengers exited the airplane, reentered, and exited the airplane a second time. These passengers' seat locations are designated with a '/'. The first exit used is represented by the upper color while the second exit is shown by the lower color.
