Ohio State Highway Patrol

Reconstruction Report

2015-304-00

*1910 West Blvd. Cleveland, OH. (Cudell Recreation Center)
City of Cleveland / Cuyahoga County*

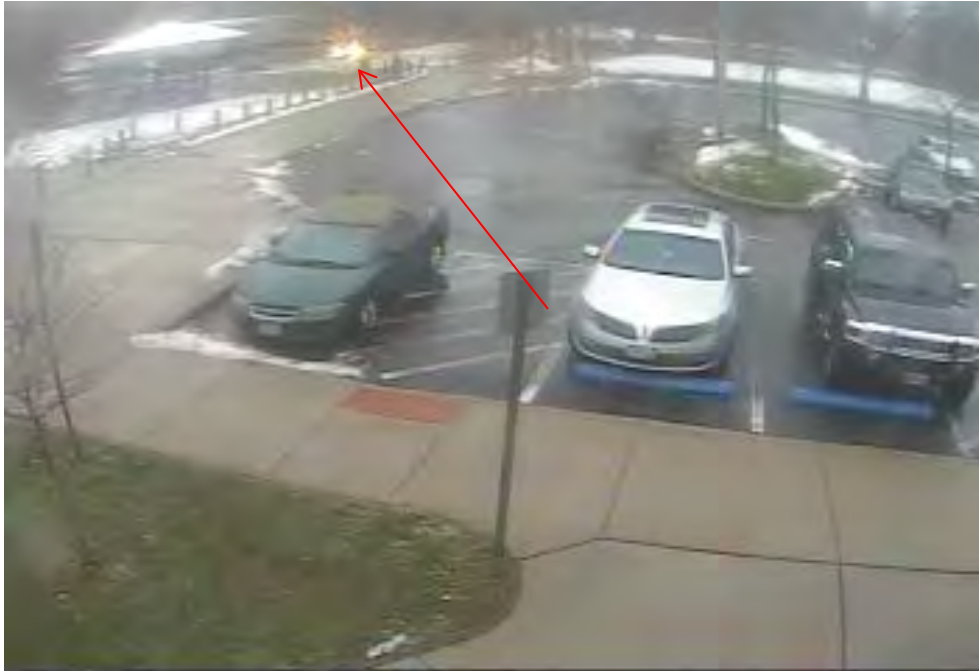
9. The headlights of the vehicles flash brightly on subsequent frames twelve and thirteen. The vehicle appears to have suddenly changed elevation or traversed a bump as its lights dip downwards and then abruptly rebound.

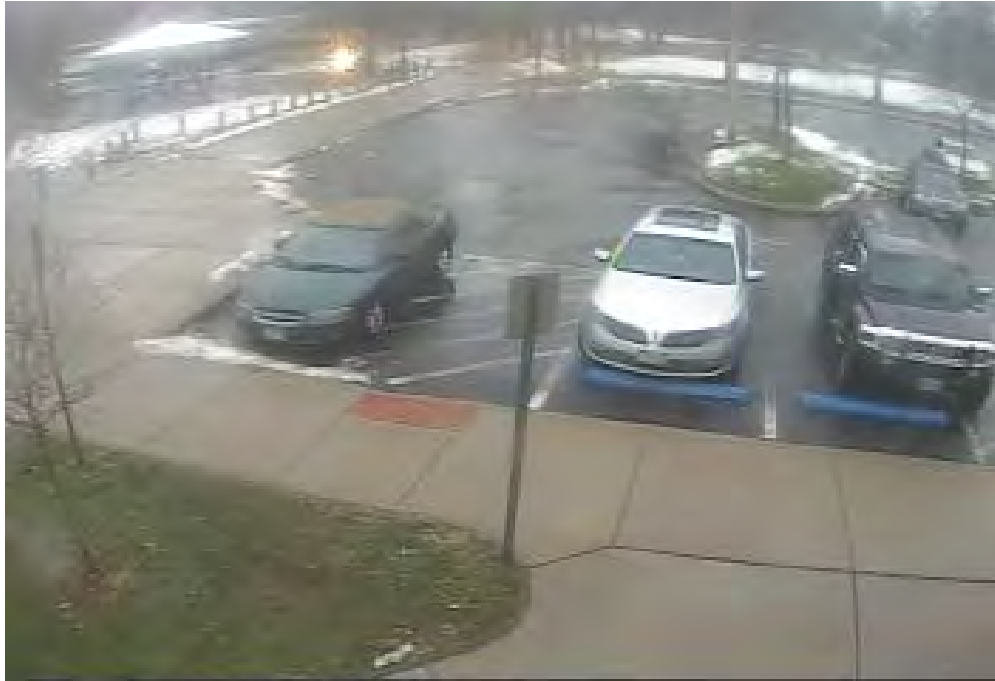
13. Two frames later, the right front headlight flashes brightly, and it appears as if the vehicle has traversed another bump or elevation change. The left front headlight remains obscured.

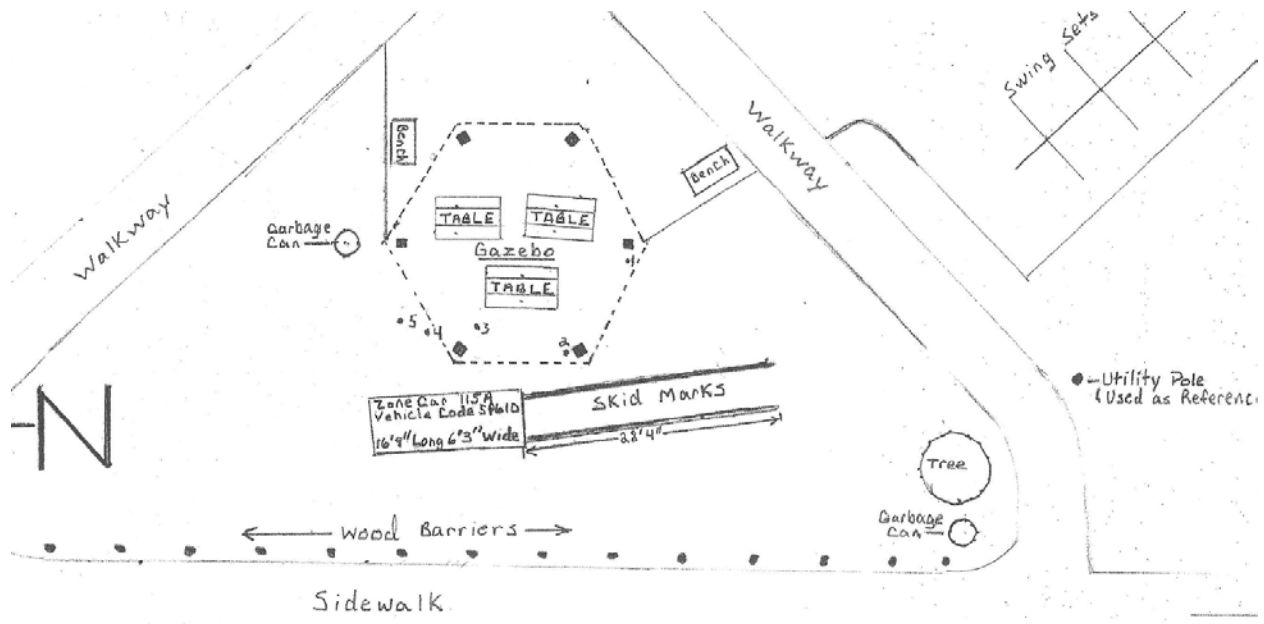
I consulted Detective Sandoval's field sketch for a visual representation of his evidence collection. The portion of his field sketch depicting pre-stop deceleration is reproduced below. **Note – Detective Sandoval's sketch is not drawn to scale.

The field sketch shows the final resting position of Car #115A with two tire marks extending to the rear (south). While the sketch is clearly not drawn to scale, the tire marks do not extend to the illustrated sidewalk or beyond in the officer's representation of the evidence.

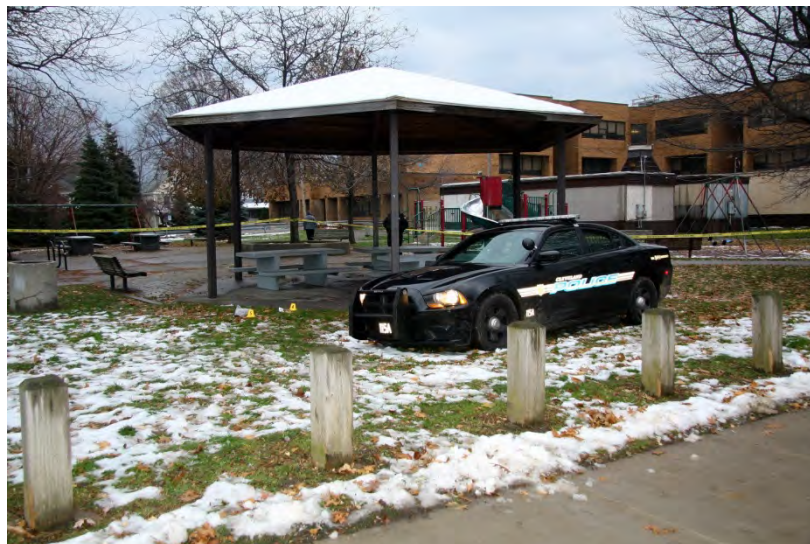
The following photograph depicts the final resting position of Car #115A from the northwest facing southeast. Faint tire marks are visible on the extreme right side of the frame.

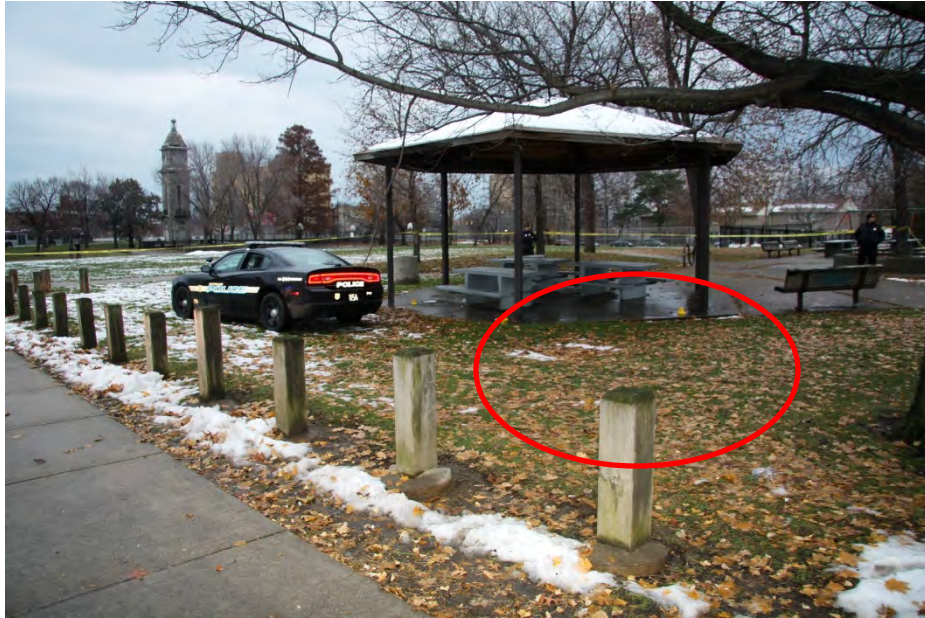
This alternative viewpoint depicts Car #115A from the southwest, facing northeast. Indentations which appear to be parallel tire marks are visible in the grass near center frame. An irregular snowy area in center frame is a sewer grate located in the grass yard.

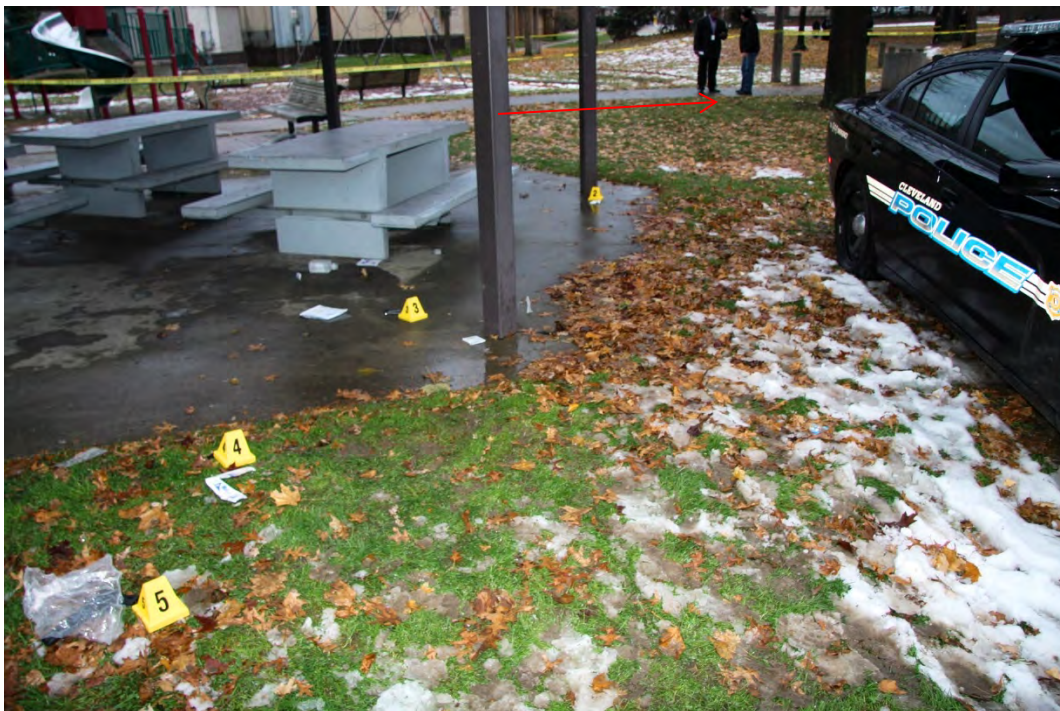
This photograph focuses on evidence located near the western edge of the gazebo and is taken from a position slightly east of the patrol vehicle, facing south. In the background near two officers standing on a sidewalk, there is a clearly visible tire mark extending south to the sidewalk.

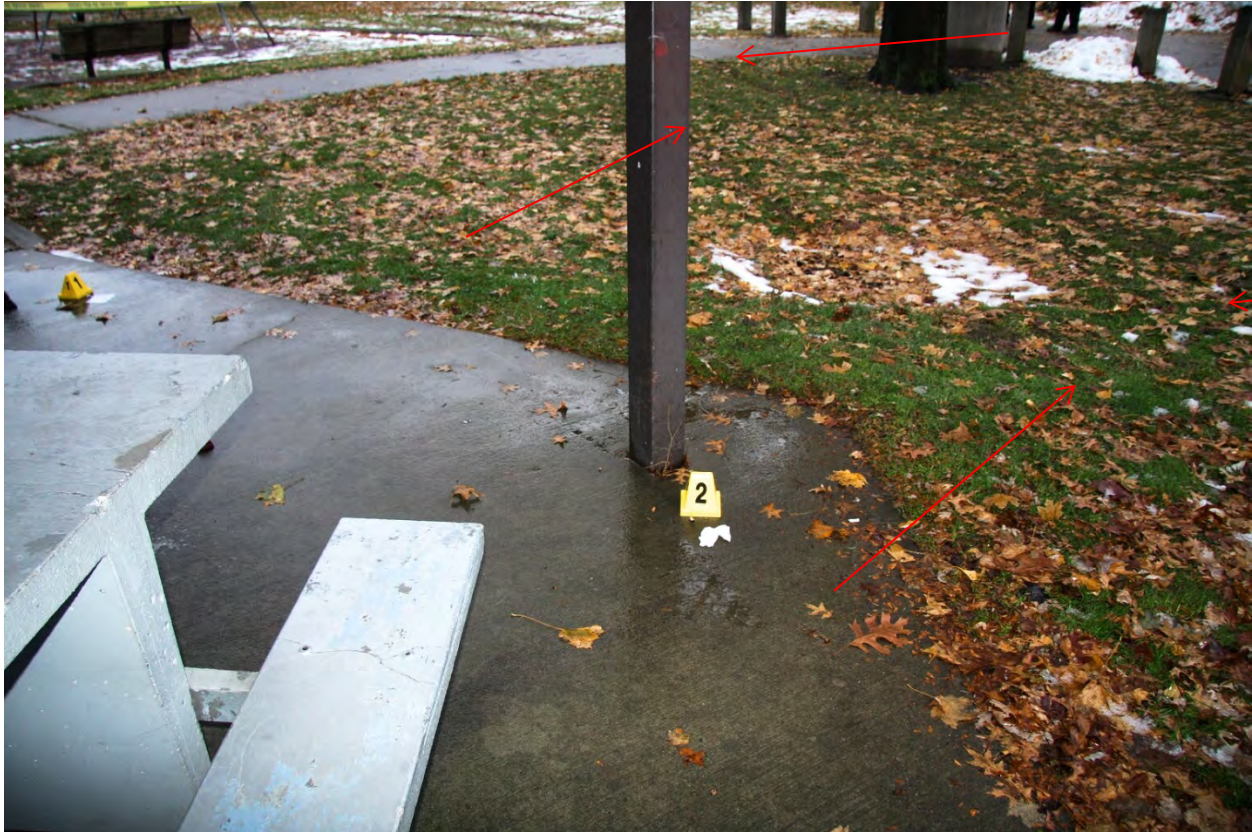
The focus of the following photograph is a bullet casing marked with evidence tent #2. It is taken from a position slightly south of the last image, as is evident by the position of a picnic table in the foreground. The snowy sewer grate is also visible in center frame. The tire mark visible in the previous photograph now comes into plain view, clearly extending to the concrete sidewalk. A second track is visible passing through the snowy, leaf covered sewer grate where it extends south until being obscured by a gazebo post. In the extreme north (top) portion of the camera frame, additional tire marks become visible.

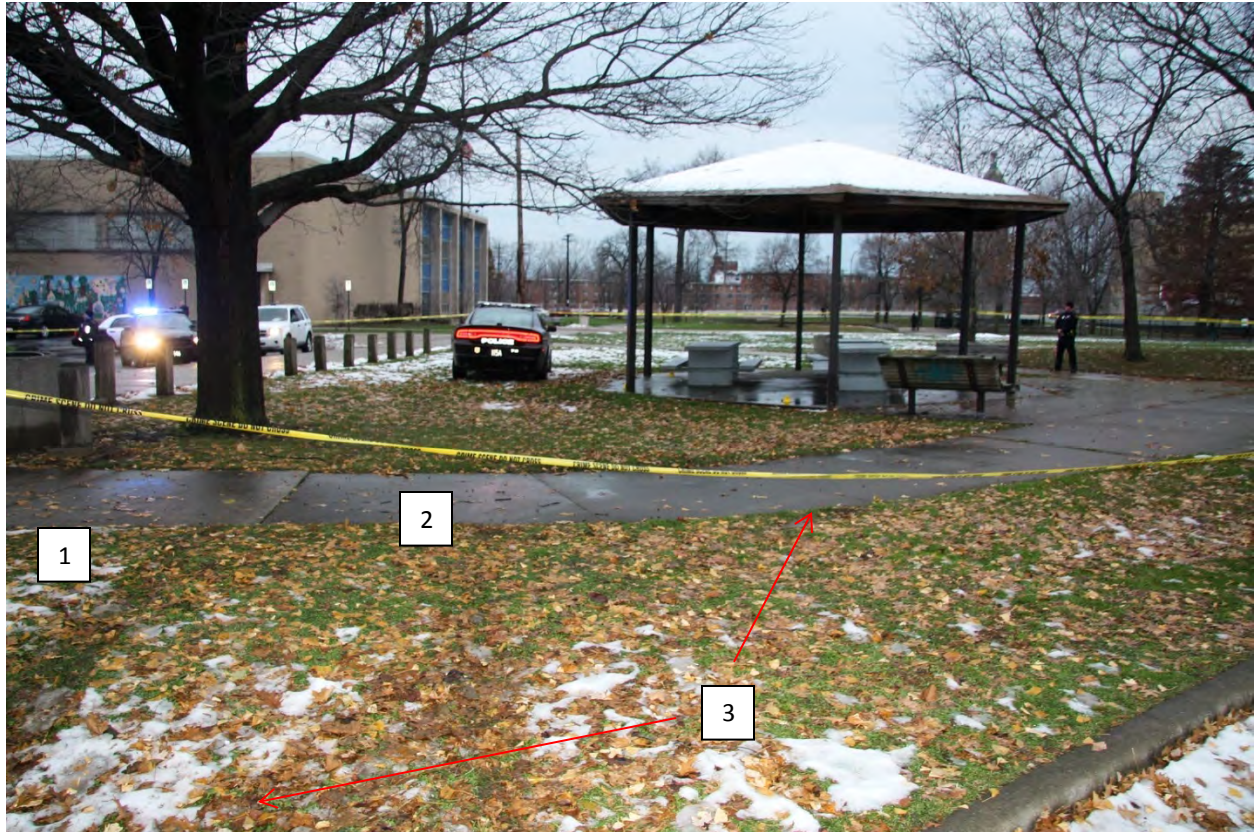
The following photograph depicts Car #115A from a southern viewpoint facing north. The snowy sewer grate remains visible near center frame. Additionally, three tire marks are visible in the lower left foreground. Two of these tire marks appear roughly parallel and head in a direction consistent with the final resting location of Car #115A. The third tire mark cuts diagonally across the right parallel mark, on a more northeasterly trajectory. A concrete curb delineating a play area is visible in the extreme lower right portion of the image.

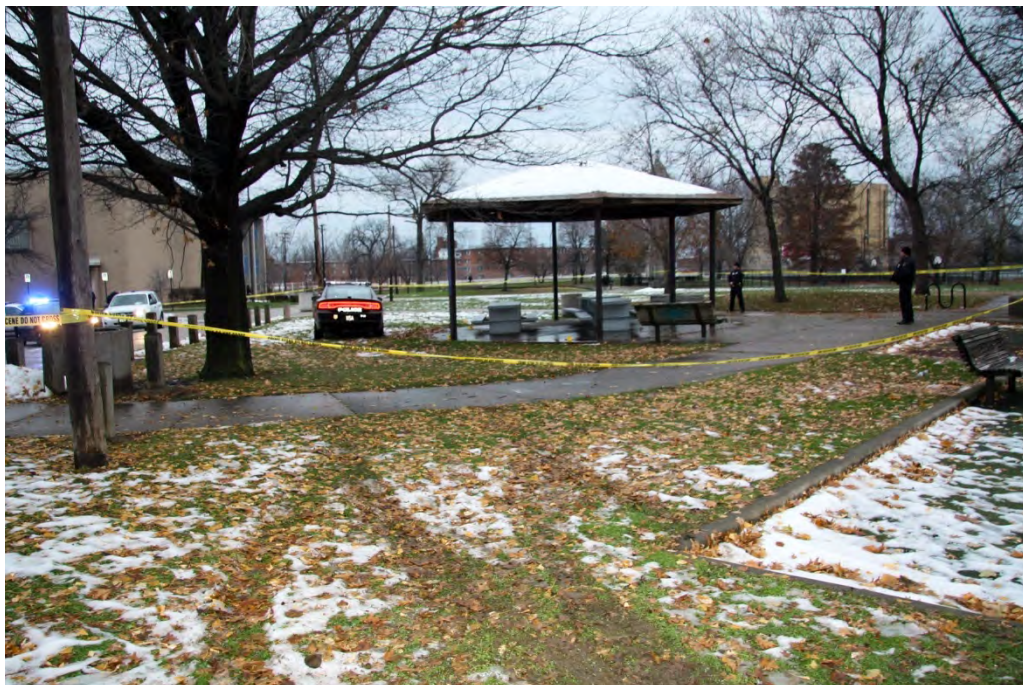
An image taken slightly south of the previous clearly shows the presence of four tire marks. Two appear straight and head towards final rest of Car #115A. The remaining two marks curve towards the right side of the frame (northeast).

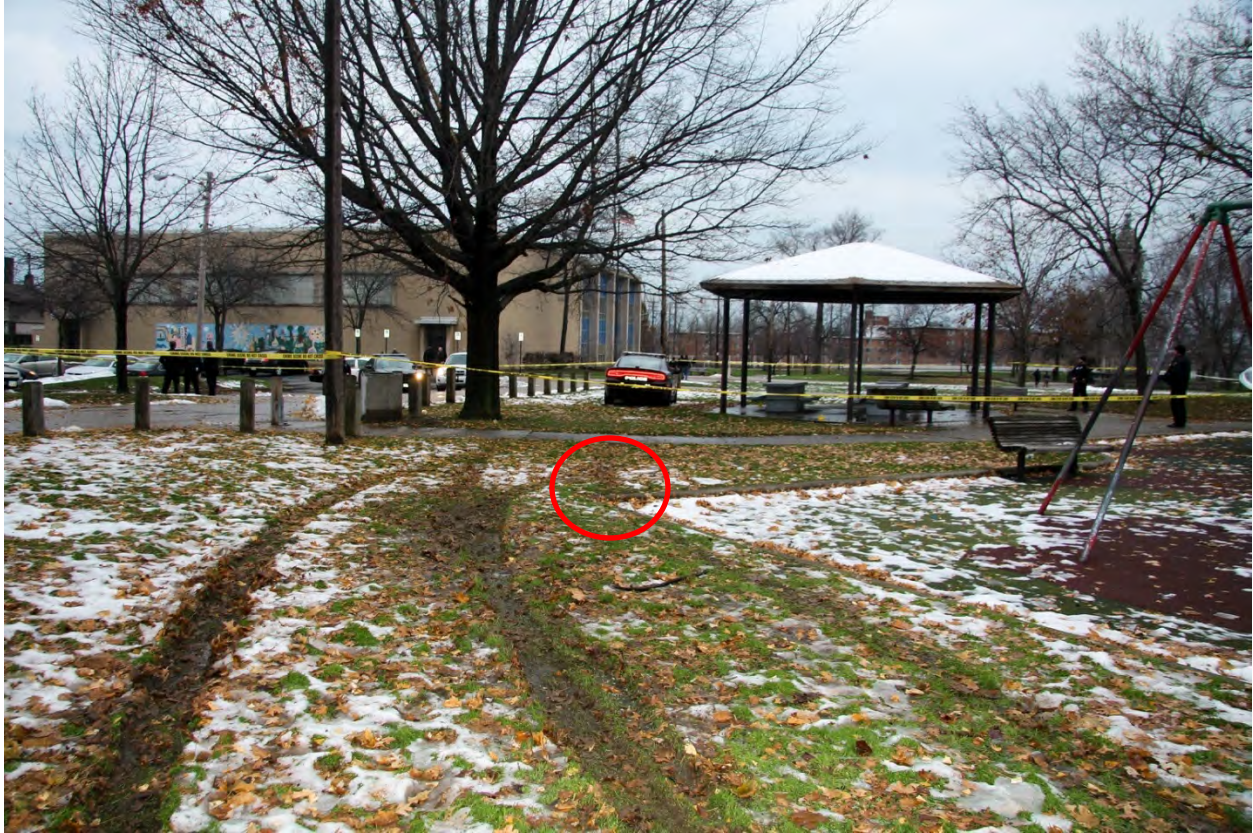
This image is further south of the previous and again depicts four tire marks in a grassy field west of a play area and swing set. The outer set of marks is much more defined and clearly arcs to the northeast. The lighter set remains more or less parallel, with the right mark visible further to the south than the left. The right mark also appears to pass over the extreme northwest corner of the play area.

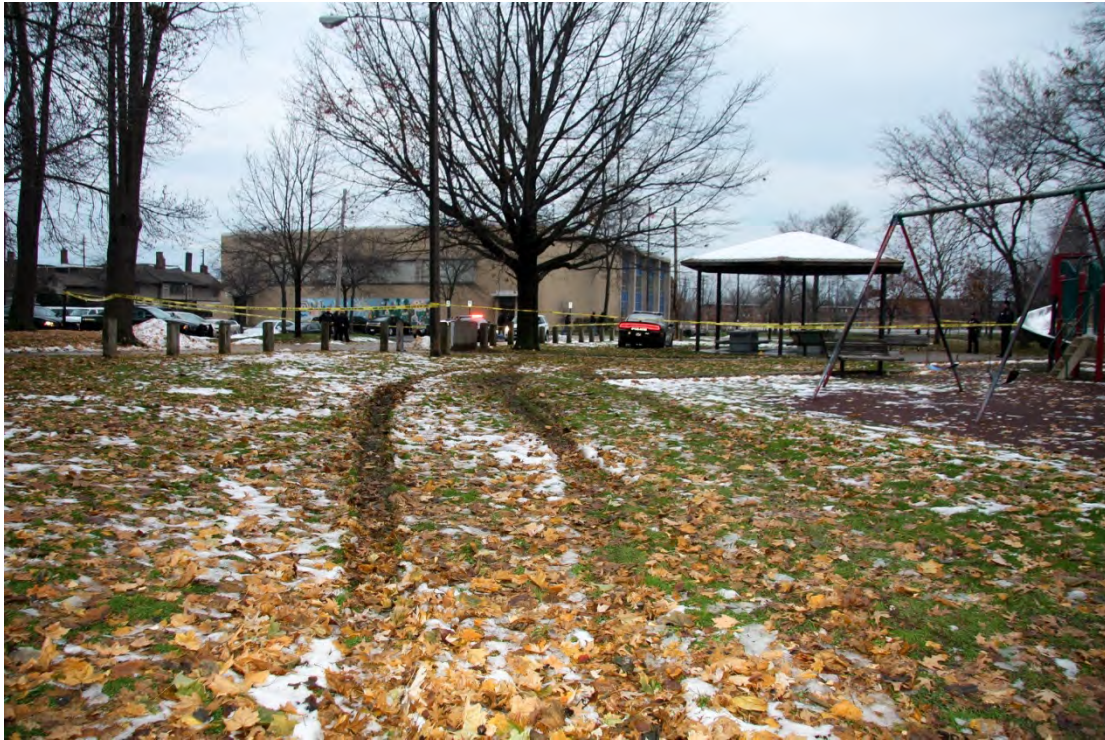
The following image is taken from a position further south facing north. It again clearly depicts two sets of tire tracks in the leaf covered field west of the play area.

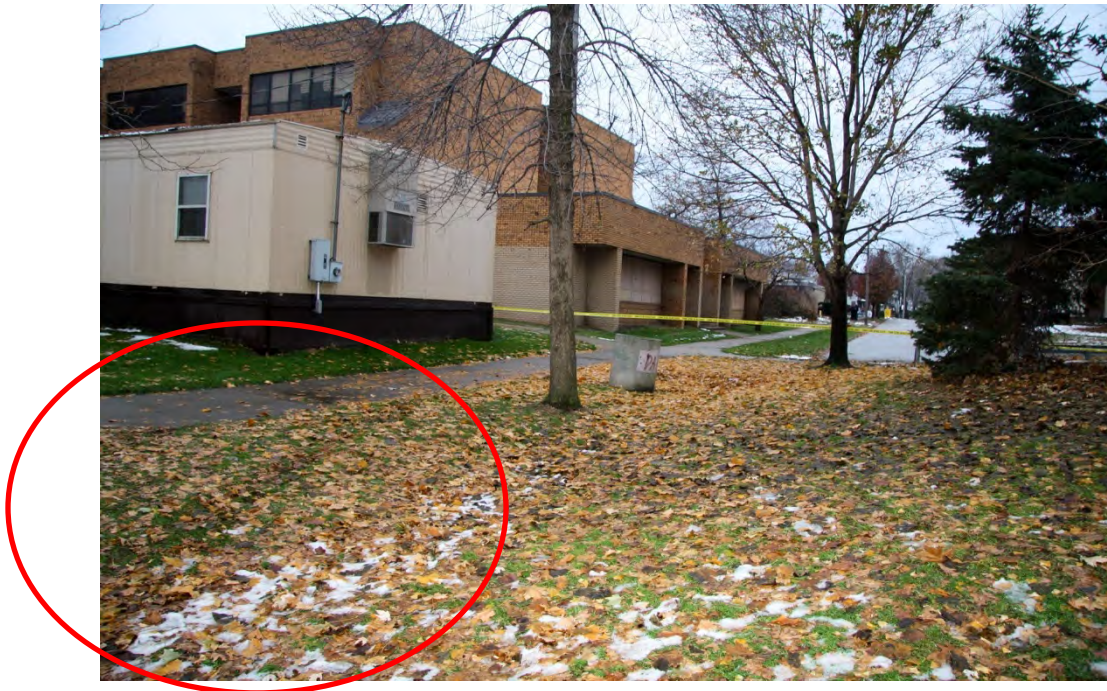
Lastly, this image faces south and is taken from a position roughly 180 degrees from the last image. It depicts W.99th St. in the background and a faint tire track in the grass to the left side of the frame heading north from the concrete sidewalk.

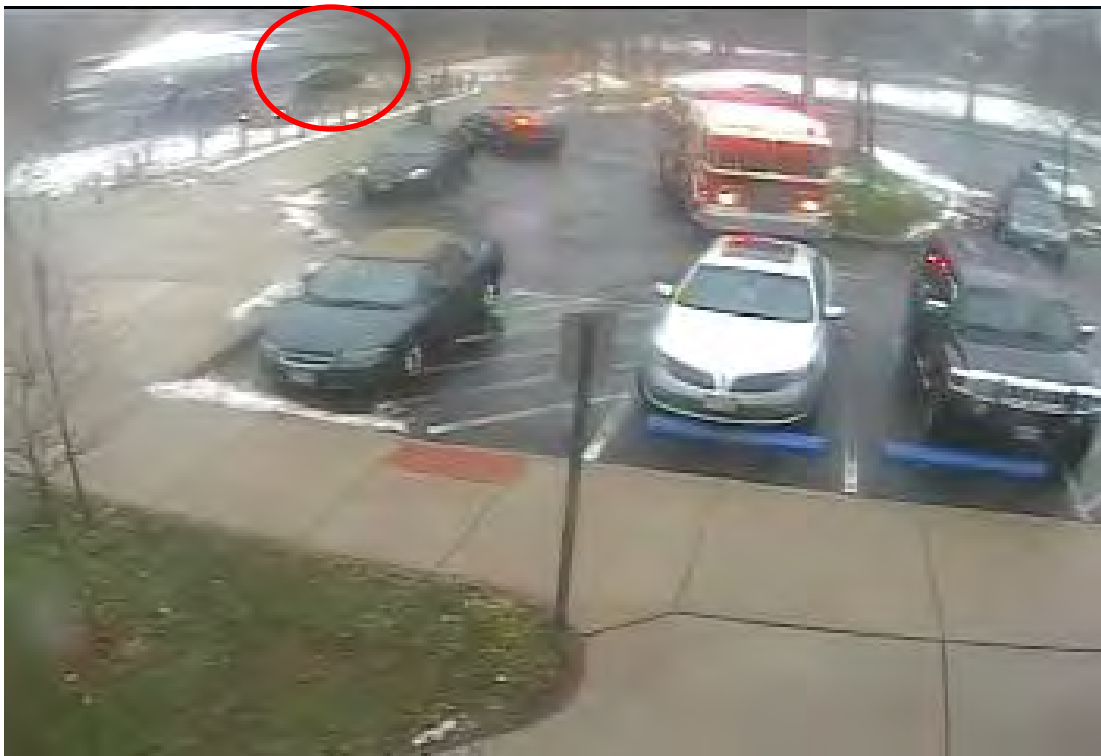
The Cuyahoga County Sheriff's investigation lists additional Cleveland Police officers arriving on scene at 1534 hours, 1536 hours, 1537 hours, 1539 hours, and 1543 hours. Consulting Camera #4 during these times reveals a second Cleveland Police cruiser duplicating the approach path of Car #115A at 15:38:29. The vehicle takes a similar path to Car #115A, but turns wider to the northeast and parks on the concrete walkway south of the gazebo.

The surveillance video clearly demonstrated the darker, northeasterly tire scuffs were created by an additional responding Cleveland Police vehicle and not Car #115A. Consequently, the path of Car #115A was reflected in the lighter, northbound tire marks depicted in the scene photography.

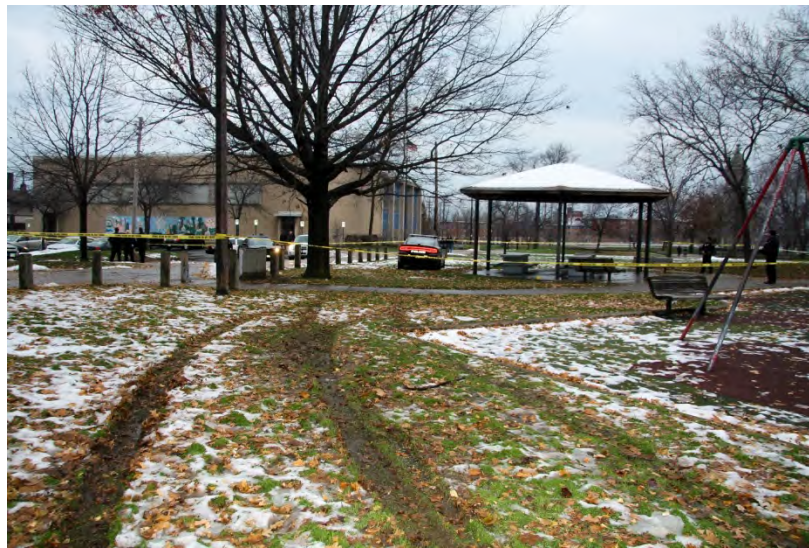
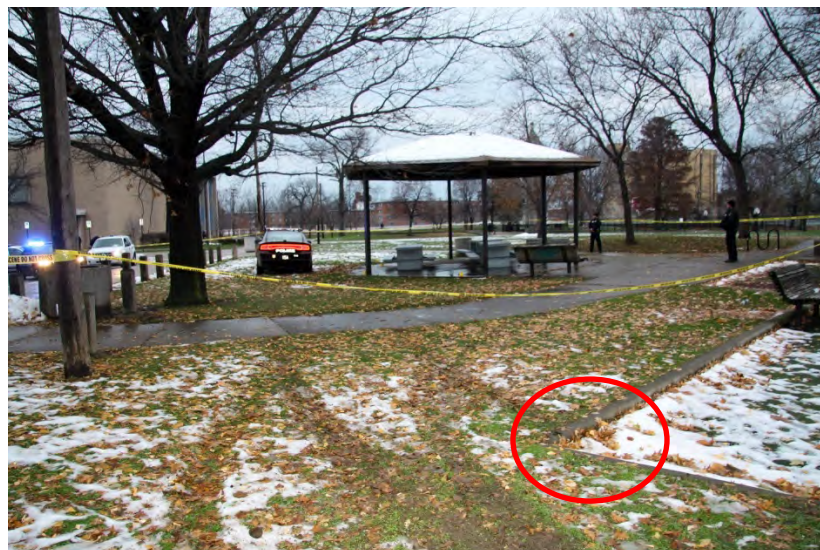
The following two images are repeated from the crime scene photograph section to illustrate the source of the second impact.

The second headlight flash captured by Camera #4 resulted from the right front wheel of Car #115A traversing the corner of the depressed play area south of the gazebo.

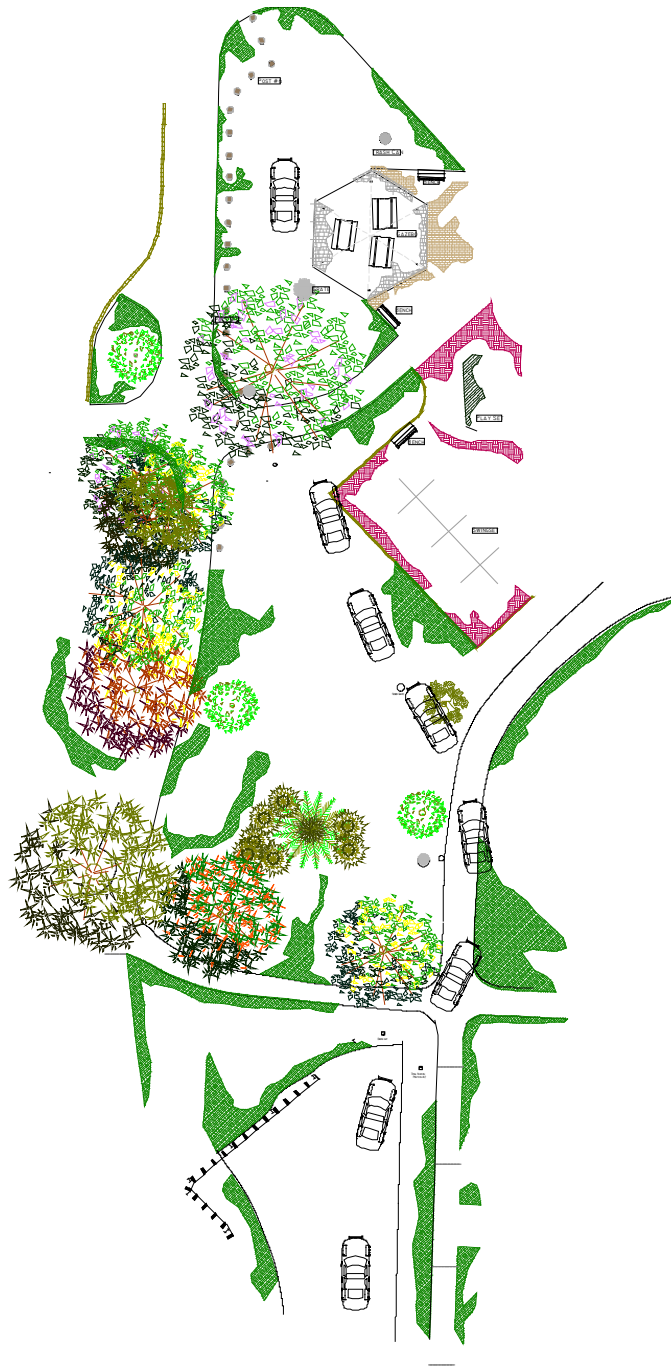
Based upon the analysis conducted in the previous section, the approximate approach path of Car #115A to the shooting area can be depicted using the scale diagram.
